GSxE and GSxP Seal Carrier

**Potential Loss of Press Fit
Performance Degradation Unlikely
Long Term Reliability Potentially at Risk**

Please reference publication **51571**.

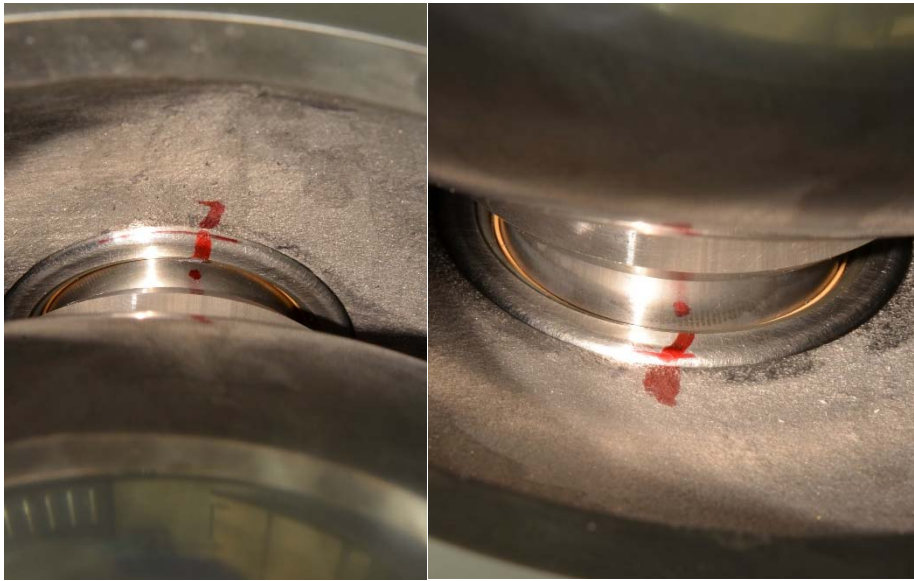
Figure 1. Bushing Movement

Woodward recently discovered a potential issue in the component dimensioning of GSxP and GSxE valves that resulted in potentially insufficient press fits. Due to friction variations, the grease retention seal carrier bushing could be pushed toward the bearing introducing parasitic torque, or be pushed out of the bore, allowing the bearing grease to escape.

Noticeable performance degradation due to seal carrier bushing movement is unlikely. If the valve appears to be operating outside of specifications, or during routine service, visually examine the inside of the valve. The seal carrier bushing should appear to be nearly flush with the inside of the housing as shown in Figure 1 below.

If one or both bushings have moved, they will appear as shown in Figure 1 above. In Figure 2 below, shafts and regulator were removed for clarity.

If the bushings have moved deeper into the housing, please monitor the performance of the valve and send it in during the next planned outage. If the bushings have moved out of the housing, please contact Woodward. A bushing that has come out of the housing will potentially reduce the life of the bearings.
